Bay Bridge Update to CTC – August 6, 2013

On July 8, 2013, TBPOC issued investigative report on A354 Grade BD High-Strength Steel Rods with findings and provisional resolution on SAS high-strength bolts

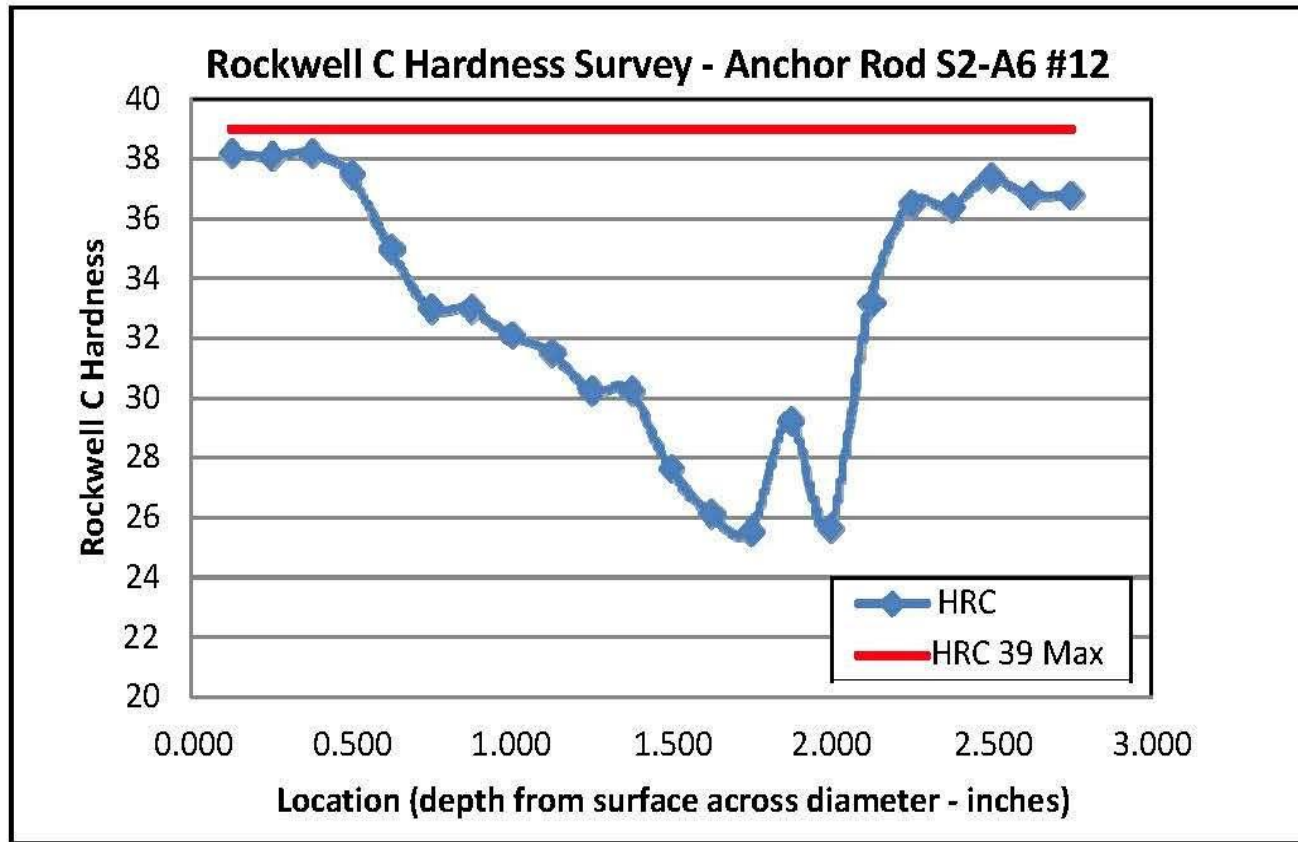
2008 Rods Failed Due to Hydrogen Embrittlement

- Rods exhibited a material susceptibility to hydrogen embrittlement with a heterogenous structure and high surface hardness.

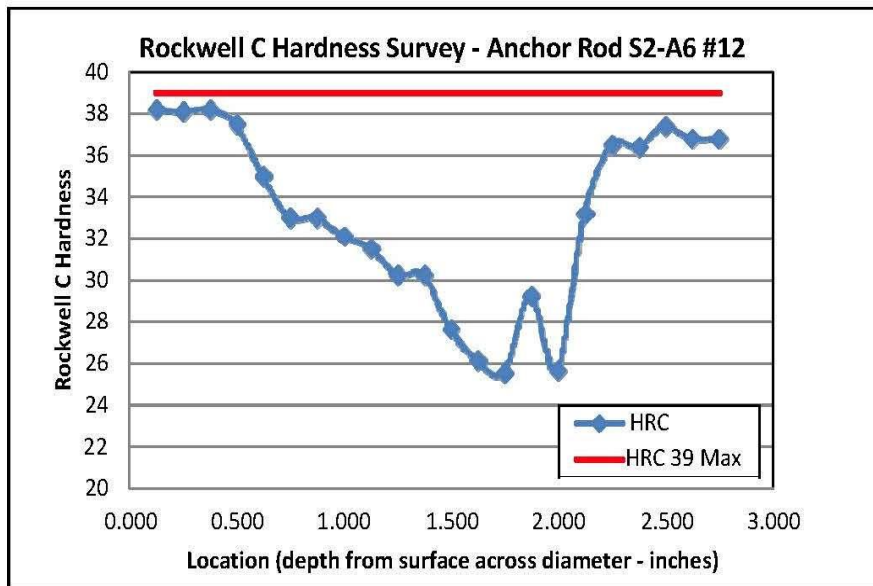
Failed 2008 Rod

Improved Hardness
